Archaeological Curation-Needs Assessment
Technical Report No. 8

An Archaeological Curation-Needs Assessment for the Legacy Resource Management Program

**U.S. Army Corps of Engineers
St. Louis District
Mandatory Center of Expertise for the
Curation and Management of Archaeological Collections
Archaeological Curation-Needs Assessments
Technical Report No. 8**

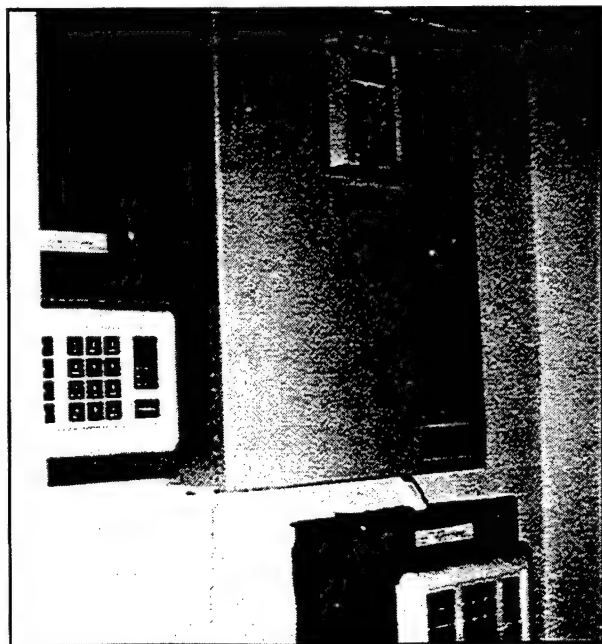
Security for the building and the collections storage area consists of an intrusion alarm (Figure 4) on exterior doors wired into the military police station, motion detectors, and controlled access. All doors have dead-bolt locks

Figure 4. Fort Lewis Military Museum security system.

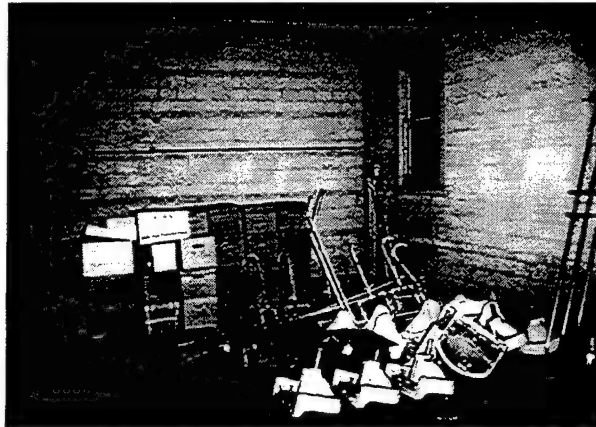
At the beginning of the visit, boxes with archaeological materials were stacked on the cement floor and/or on a piece of plywood on the floor (Figure 6).

Figure 6. Fort Lewis collections stored on floor in Building T4294.

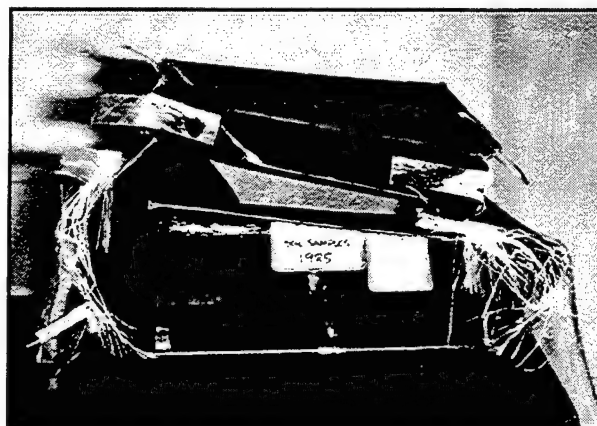
Figure 7. Severely compressed secondary containers for Fort Lewis collections.

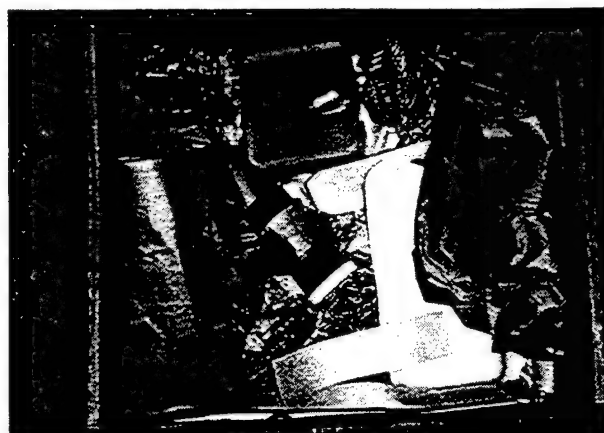
Several types of secondary containers contain archaeological materials (Figure 8). Plastic bags (42%) are secured with zip-lock closures. Paper bags (46%) are folded. A variety of nested containers store artifacts within many of the secondary containers. These include plastic vials, paper envelopes, plastic bags,

Figure 8. Several types of secondary containers contain archaeological materials.

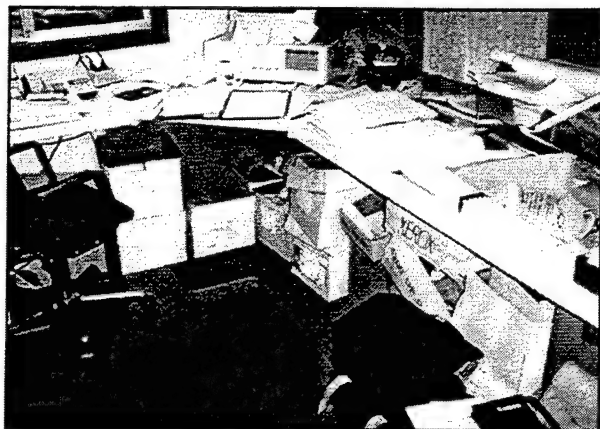
Figure 9. Paper records for Fort Lewis archaeological collections stored in Building 4301.

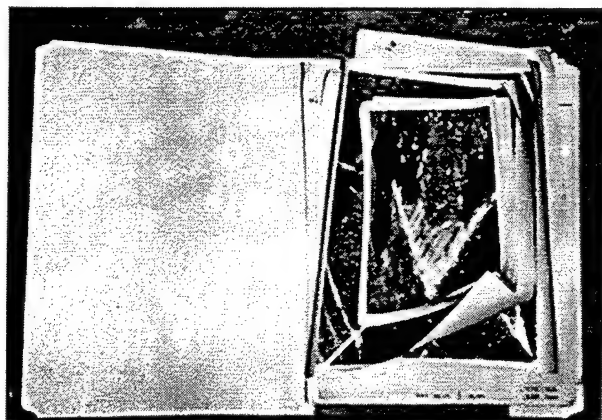
Figure 10. Condition of Fort Lewis photographic documents (note curling edges).

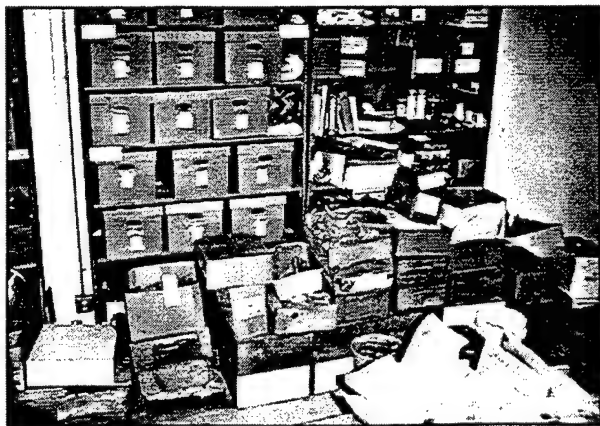
Boxes are stacked on the floor against the walls of the dining room.

Figure 12. Storage units for collections in Building 127 at NSB San Diego.

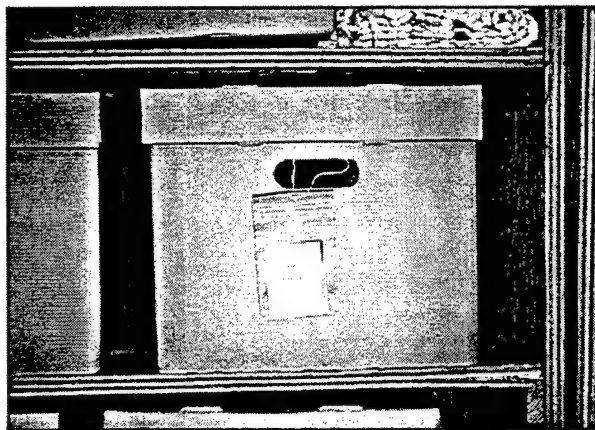
Box labels for material stored in the acidic cardboard boxes consist of acid-free tags inserted into polyethylene plastic zip-lock bags (Figure 13). The plastic label holders are affixed to the boxes by string looped through a hole in the lip of the bag and around the box handle. Label

Figure 13. Type of box label used for NSB San Diego collections.

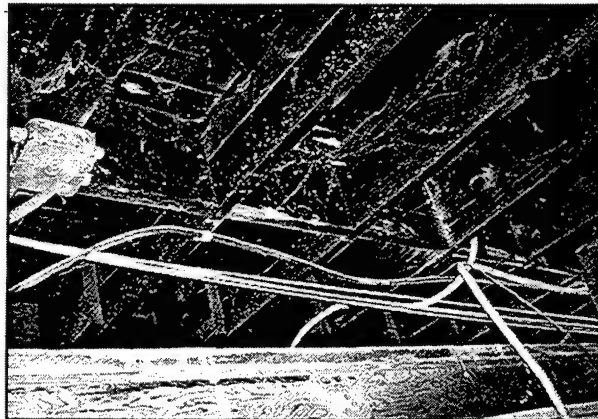
No integrated pest-management program is in place. Spider webs and dead insects were observed during the visit (Figure 15).

Figure 15. Evidence of lack of pest management in locker under Building 5.

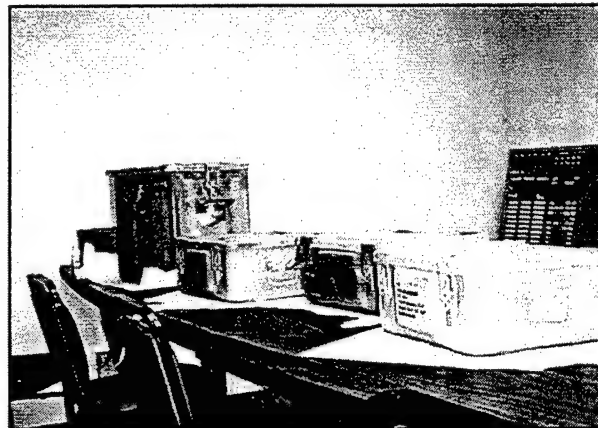
Figure 16. Type of primary containers used for collections in the storage locker.

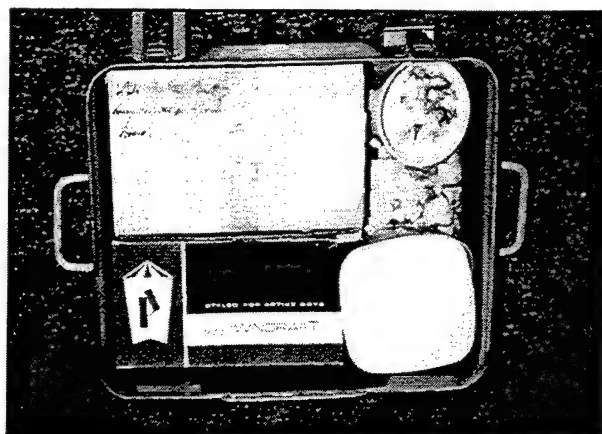
Five types of secondary containers (Figure 17) are present (Table 15). The majority (60%) of the containers include adhesive labels written in marker and/or pen stating content information. All are either directly labeled or contain adhesive labels. The plastic bags with twist ties are

Figure 17. Types of secondary containers for collections in the storage locker.

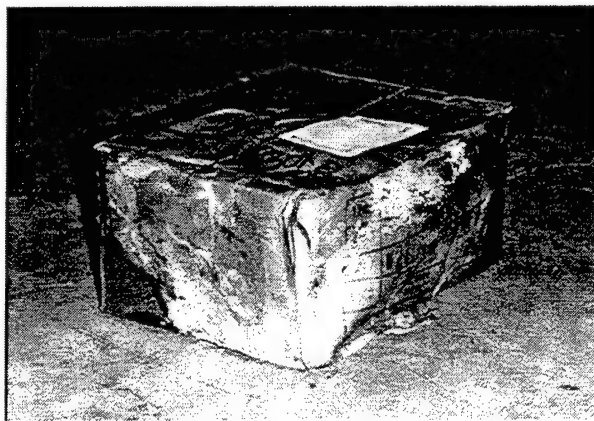
Figure 22. Example of water-damaged box in library collections area.

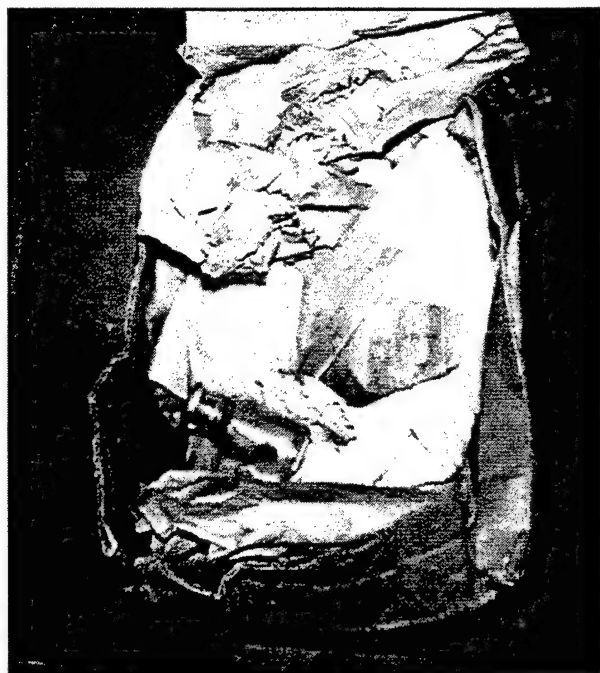
Figure 23. Example of water-damaged box in the shipping container.

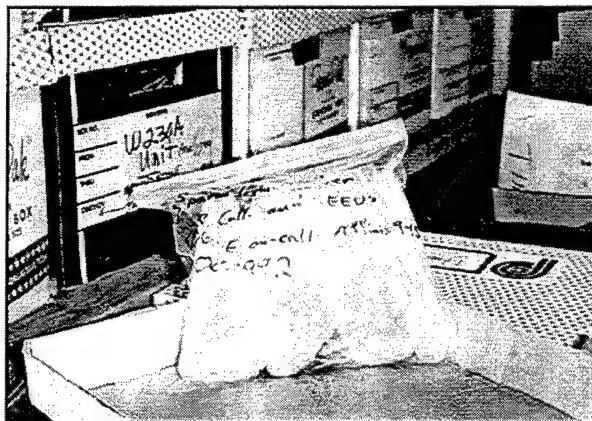
NAS Miramar artifacts are stored in a single 2-mil polyethylene zip-lock bag (Figure 26). The bag is labeled directly in black marker with the contents, date, and job number information.

Figure 26. View of the secondary container holding NAS Miramar artifacts.

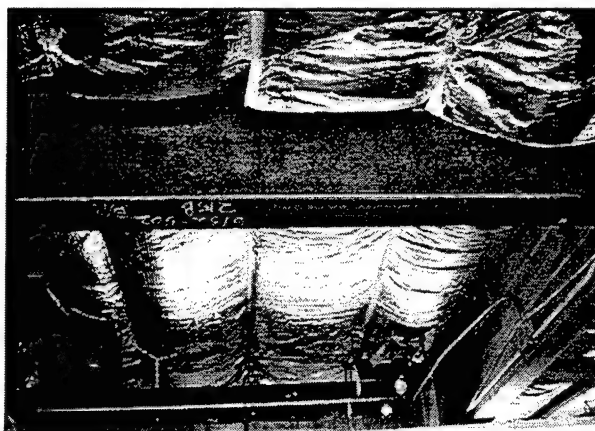
Figure 28. Ceiling beams and insulation in collections area.

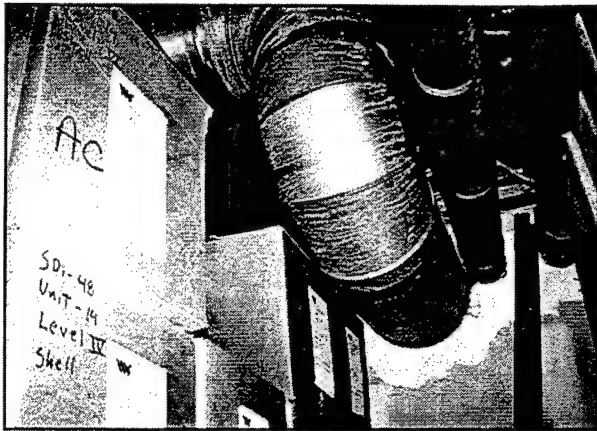
Figure 29. Ductwork touching primary containers in the OGDEN repository.

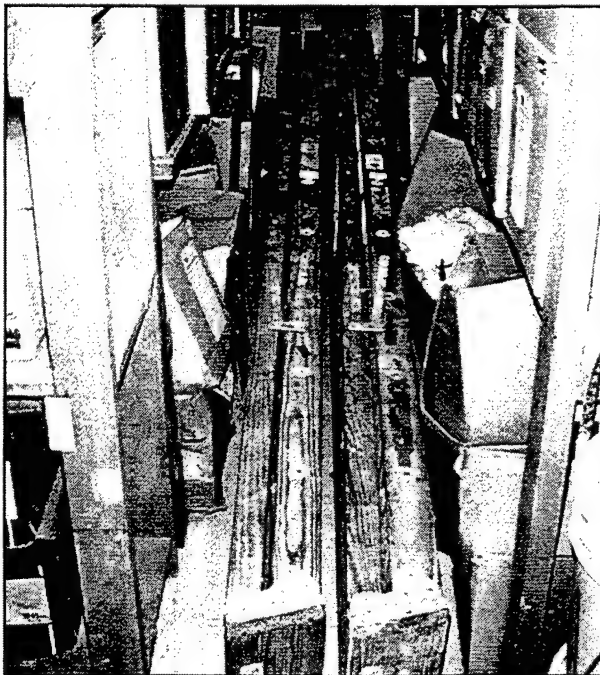
Figure 30. Clutter noted in OGDEN repository.

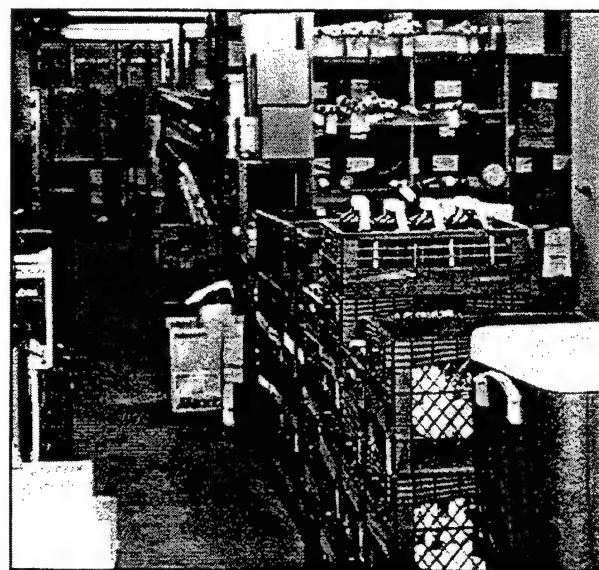
Temperature in the archaeological materials storage area is controlled by a central heating and air conditioning system. Humidity is not monitored or controlled. Staff indicated that dust filters exist for the heating/air conditioning system, but dust was abundant on all artifact boxes, especially those located directly under the air ducts. Light is provided by uncovered fluorescent tubes. The area is maintained on an as-needed basis by the curatorial staff. Adjacent to the north end of the storage area in the larger of the two rooms, and not separated by a wall, is a nonventilated area that Analytical Technologies uses to store hazardous chemicals. Multiple bottles stored in boxes are stacked on the floor (Figure 31).

Figure 31. Chemicals stored on floor in OGDEN repository.

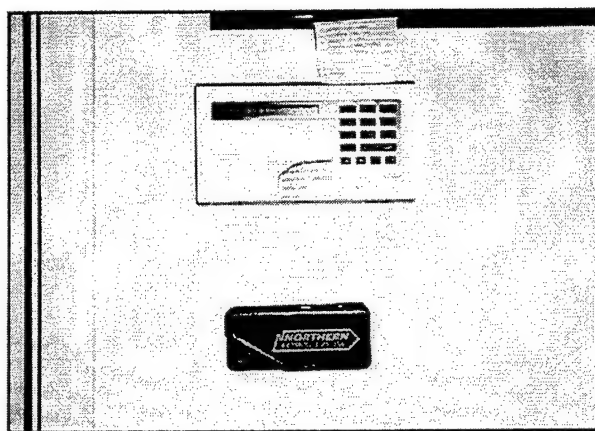
Security for the entire building is the same as that described for the archaeological material storage area. Additionally, the laboratory/records storage area is protected by a key lock on the door, motion detectors inside the room, and controlled access by use of an electronic key card system. The laboratory/records storage area was

Figure 32. Key card security system at OGDEN repository.

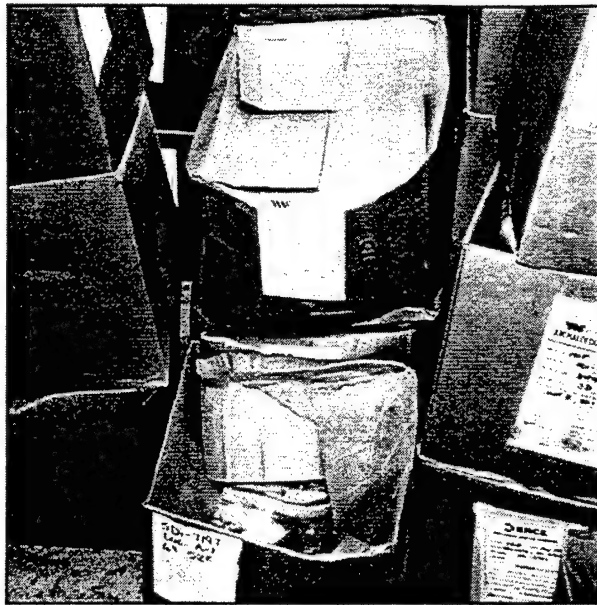
Two types of storage units are used to store archaeological materials. The majority (59%) of the storage units are boxes that are stacked four or five high on the concrete floor in the smaller of the two storage rooms (Figure 33). The remainder (41%) are stored on homemade wooden shelves in the larger storage area (Figure 34). The shelves

Figure 33. Storage containers for collections at OGDEN.

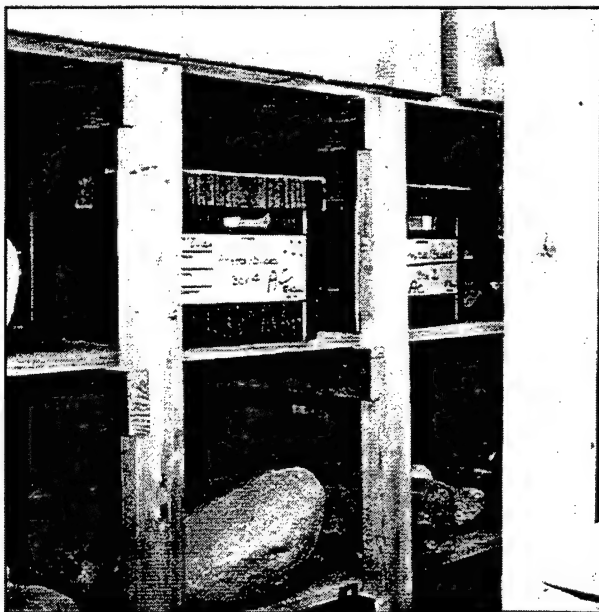
are constructed of unsealed 2-x-4-inch wood uprights and 1/2-inch plywood shelves. There are a total of eight rows of shelves, each measuring 12 x 2 x 6.5 (length, width, height). Each row contains three shelves, and boxes are stacked too high on the shelves. Many boxes in the smaller of the two collections storage areas are compressed from being stacked on the floor. All of the boxes are dirty and dusty.

Figure 34. Other collections at OGDEN stored on wooden shelves.

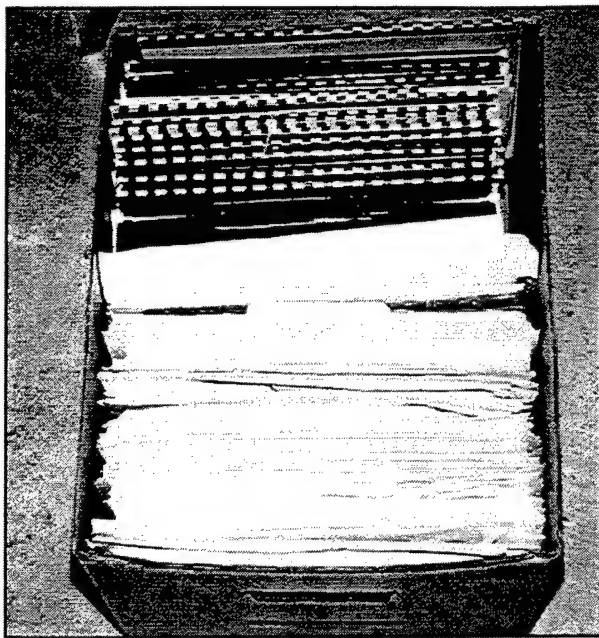
Paper records stored in the storage area are not archivally processed. The records are stored in various-sized acidic cardboard boxes with telescoping lids (Figure 35). When arranged, the records are sorted by project name and number. The majority of the boxes are directly labeled in marker with a mixture of box number, site number, site name, and contents. The remaining

Figure 35. Type of primary containers used for associated records stored at OGDEN.

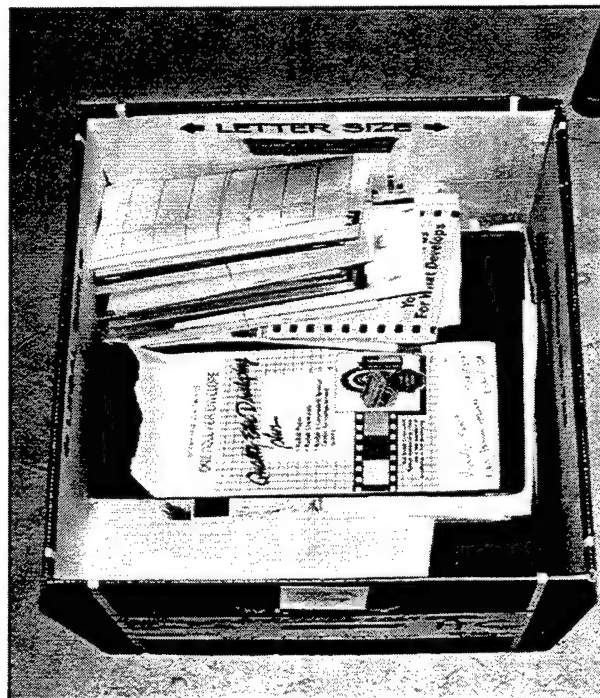
Figure 36. Storage of photographic documents at OGDEN.

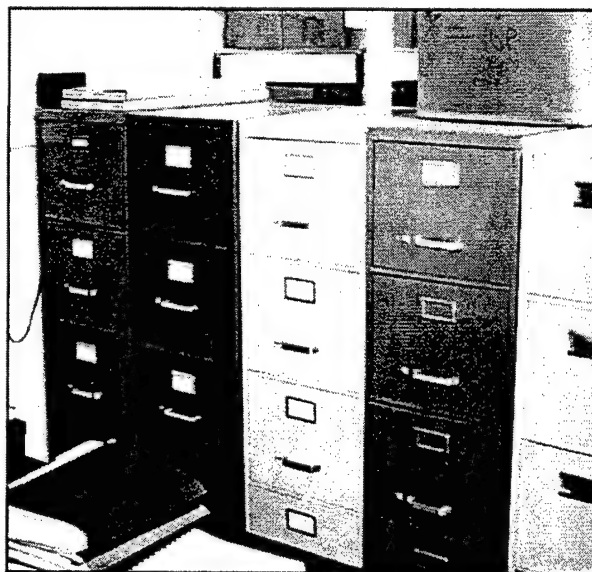
All original paper records are stored in four-drawer enameled metal file cabinets (Figure 39). These cabinets serve as the south wall of an office in the laboratory area. Records are arranged by project number and are stored in acidic manila folders, hanging file folders, and several three-ring binders within the file cabinets. File drawers contain acidic paper labels in metal tag holders. The drawer labels include project number information written in marker. Folder labels, both adhesive and direct, are written in marker and/or pen and contain project number information. A

Figure 39. Storage units for documents stored at Gallegos and Associates.

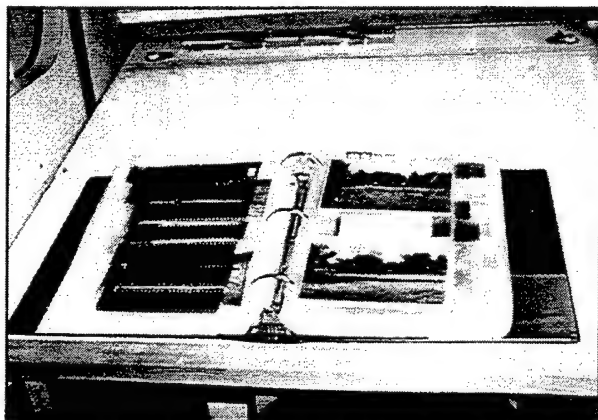
Figure 40. Photographic records at Gallegos and Associates and their secondary container systems.

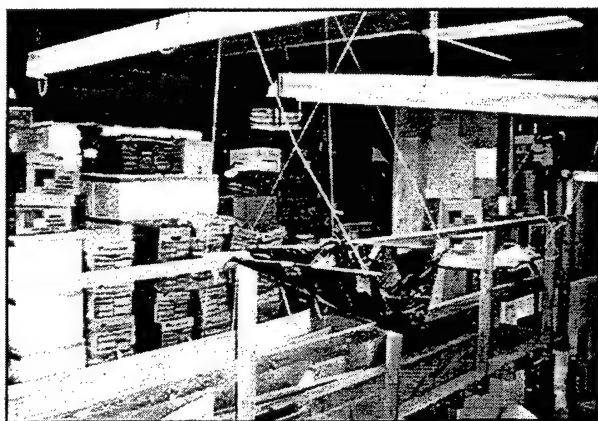
Figure 42. Handmade "rain catcher" is evidence of leaking roof at the Archaeological Resource Service repository.

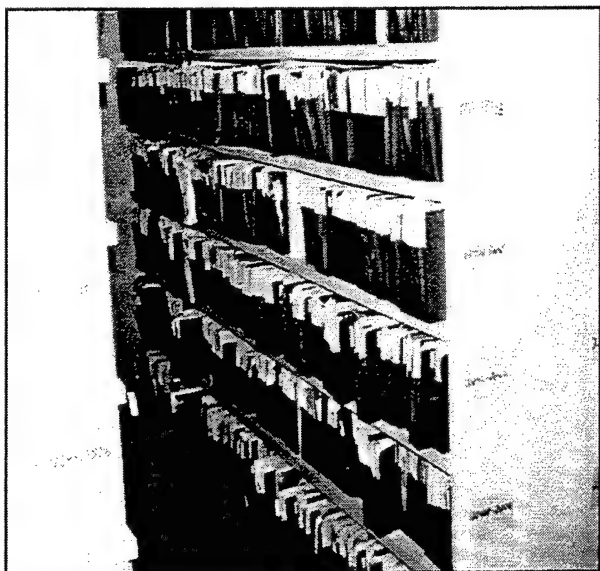
Figure 45. Archives room at RECON
(note records stored on floor).
